REPORT ON USATECOM PROJECT NO. 8-3-0030-06F  
PRODUCT IMPROVEMENT TEST OF BOLT ASSIST DEVICES  
FOR RIFLE, CALIBER .223, AR15  
REPORT NO. DPS-1120  
NOVEMBER 1963

U. S. ARMY  
DEVELOPMENT AND PROOF SERVICES

Three models of charging handle bolt assist devices for the caliber .223 AR15 rifle were evaluated for effectiveness in manual extraction and bolt closure operations. A plunger-type bolt closure device was also evaluated. The devices were tested for operation under various adverse conditions, and other special tests were also conducted. Only the plunger-type bolt closing device provided an effective means for closing the bolt under adverse conditions. The modified charging handle did not provide adequate means for extraction operations under adverse conditions. It is recommended that the charging handle bolt assist device tested not be adopted.

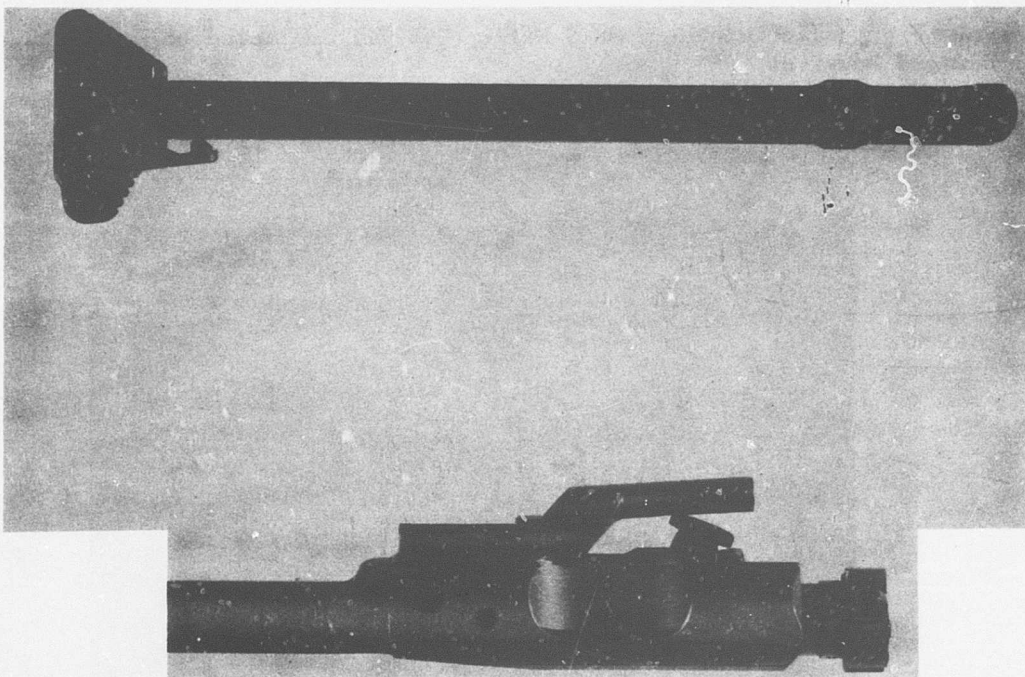
The standard AR15 rifle upper receiver did not crack in the area below the carrying handle. All the components of the magazine except the tube were blown downward and free of the rifle. No rounds were stored in the magazine at the time of the cook-off. Figures 9, 10, and 11 show the over-all view of the rifle, the damaged bolt and undamaged charging handle, and damaged receiver, respectively.

Figure 10: Damaged Bolt and Undamaged Charging Handle from Standard AR15 Rifle (008271) Subjected to Cook-Off.

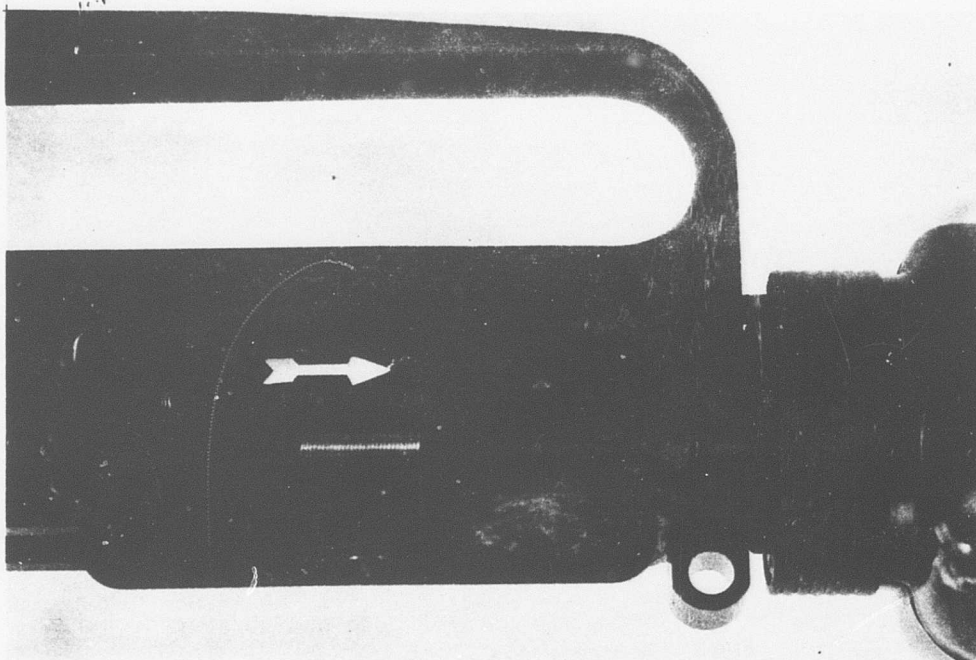
Figure 11: Standard AR15 Rifle (008271) Subjected to Cook-Off. Note Damaged Receiver.

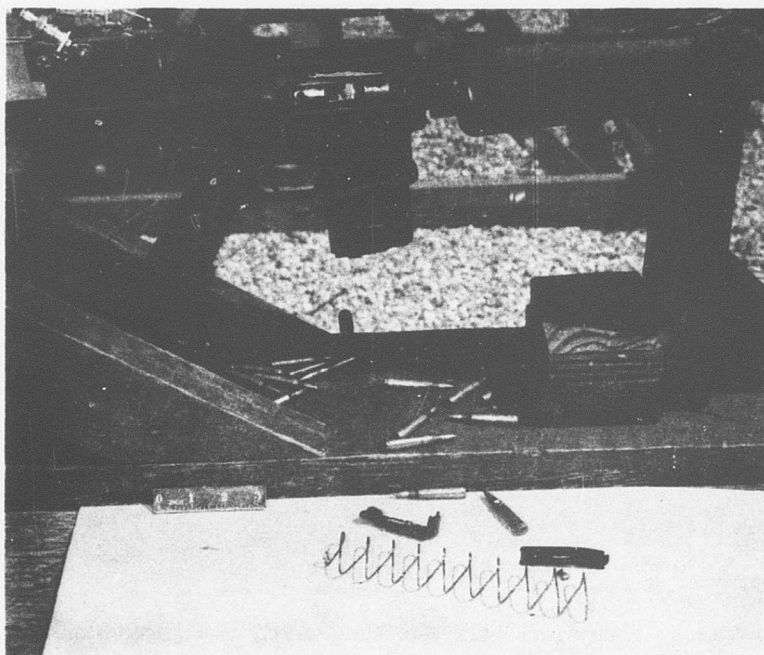
Figure 12: Rifle, AR15 (012548), with Bolt Assist Device Subjected to Cook-Off.

The receiver of the AR15 rifle with the modified charging handle was cracked forward and rearward of the riveted cam plate. All the components of the magazine, except the tube and 19 unfired rounds, were blown downward and free of the rifle. Other than slight damage at the mouth of the carrier key tube, the bolt group appeared undamaged as a result of the cook-off. Additional details on the damages are contained in Appendix C. The rifle is shown in Figure 12.

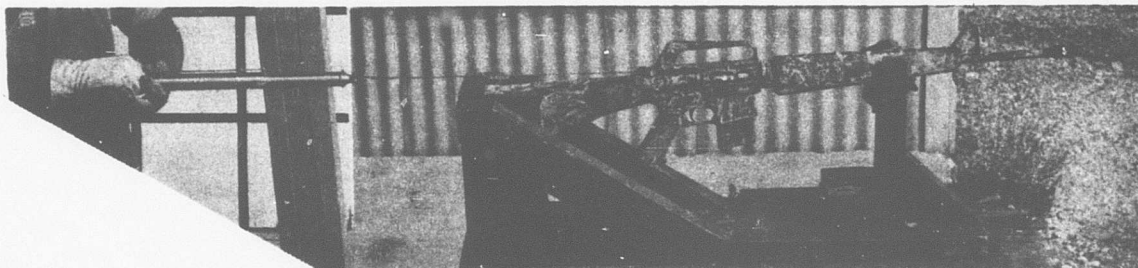
The force required to clear the rifle of cases which failed to extract, after the rifle and ammunition were subjected to a mud test, was recorded similarly to that described for extraction and ejection of damaged cartridges (Figure 22).

Figure 22: Spring Scale Attached to Rifle Charging Handle to Record Force Required to Extract and Eject Cartridge Case of Fired Round, after Rifle and Ammunition Were Submerged in Standard Mixture of Mud and Rifle Failed to Extract Fired Case.

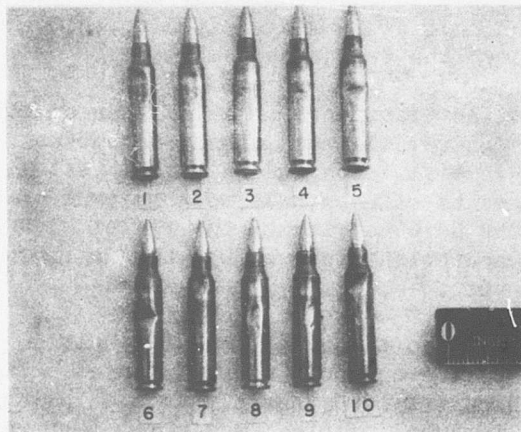
Figure 24: Typical Examples of Damaged Cartridge Cases Used in Extractive and Bolt Closure Force Measurements.
